Public Service Vehicle Revision Record

About this Manual

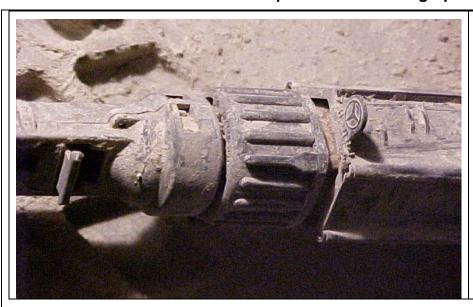
Plastic sleeve seals are acceptable but will require an embossed identification, (see example to left).
